Product Update

SC100 Speed Controller

New Firmware – Release 1.7.0

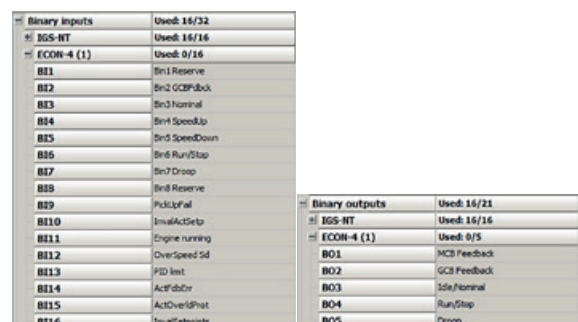
- Binary input **Bin1** was renamed to **Bin1 Reserve**.
- Binary input **Bin8** was renamed to **Bin8 Reserve**.
- Binary input **Reserve (BI9)** was renamed to **PickUpFail**.
- Binary input **Reserve (BI10)** was renamed to **InvalActSetp**.
- Binary output **Reserve (BO1)** was renamed to **MCB Feedback**.

New designations in the AIO software GenConfig
